A Landslide Risk Management Approach for the  
Stillwater to Ngakawau Rail Corridor (SNL96 to 126km)  
in the Lower Buller Gorge, New Zealand

A thesis submitted in partial fulfilment of  
the requirements for the degree of

Master of Science in Hazard and Disaster Management

**UNIVERSITY OF CANTERBURY**  
**2012**

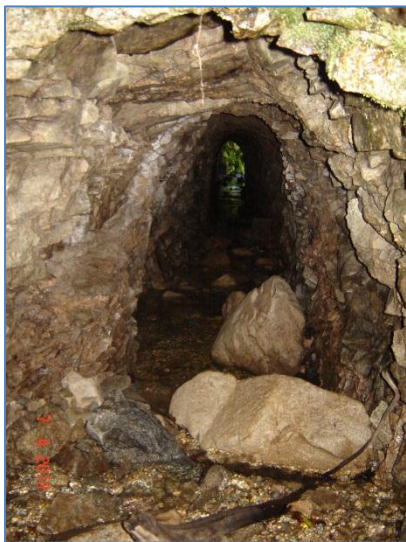
The decision to undertake stream diversion in the 1980s by constructing an approximately 35m long tunnel was carried out to improve the control of overland water flow. One incident was recalled post-1990 (per comms, Gary Hegan, September 2010) that involved the diversion tunnel becoming blocked and associated overtopping of the manually constructed boulder dam. This incident impacted rail operations and tunnel clearance was carried out as soon as practicable.

**Figure A5.11: Diversion tunnel entrance (~1.5m in height)**

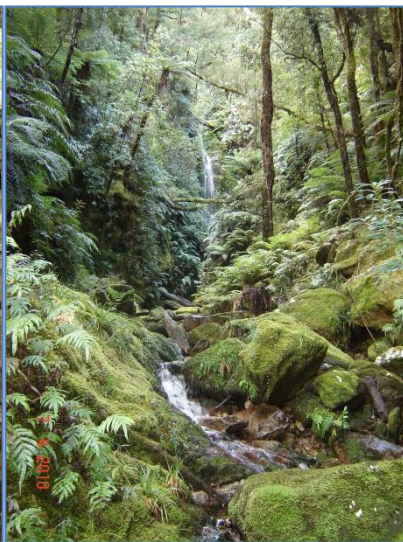
Figure A5.10 shows the steep nature of the bush-covered slopes above SNL121.0km, and the extent of the catchment that feeds the partly incised gully system on the lower slope. The size of the granite blocks that have been transported through the system is evident in Figures A5.11 and A5.12, and boulders exceeding 1m<sup>3</sup> were present upstream of the tunnel portal site. Areas of slope movement in the upper catchments are visible in Figure A5.10 (arrowed), and localised shallow failures in near-surface weathered granite were evident in the vicinity of the diversion tunnel itself. This is part of the normal weathering cycle in granite bedrock on steep slopes with high annual rainfall, and episodic extreme storm events involving regolith saturation and translational sliding at the bedrock interface.

**Figure A5.12: View looking upstream from diversion tunnel**

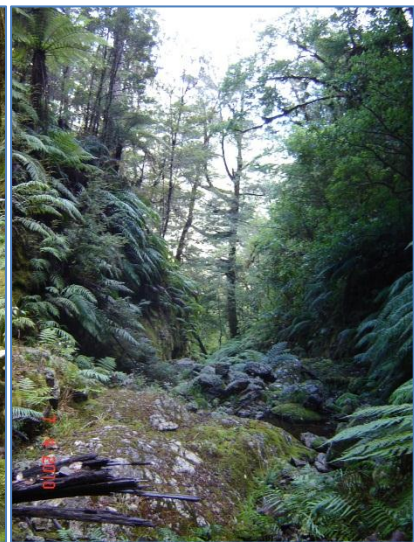
**Figure A5.13: View looking downstream and edge of rock boulder dam**

- The absence of machine access to the diversion tunnel precludes remedial measures, other than manual, to maintain the site, or to repair, as required, the non-engineered boulder dam that is currently controlling water flow (Figure A5.13).
- Annual maintenance inspections are inadequate in the event of an extreme (for example 1 in 10-year return period) storm event, and protocols are advised for such situations.
- Redesign and armouring of the existing boulder dam, with provision for storm overflow, should be undertaken as a priority, together with a detention basin upstream of the tunnel inlet.
- Large boulders removed from the tunnel inlet (Figure A5.11) could be used for armouring as required, the granite blocks being hard, strong and durable materials suitable as armour.
